Doc. no:	0100-0001 V03	Doc. Type:	Blade Service Standard	Page:	1 of 20
Created:	2012-11-29	Description:	Generic Inspection of Blades	Language:	GB
Reviewed:	2019-01-08	Blade type:	All types in service	Issued by:	OS

The purpose of this document is to provide general guidelines to monitor, inspect and document the operating conditions for all types off WTG blades.

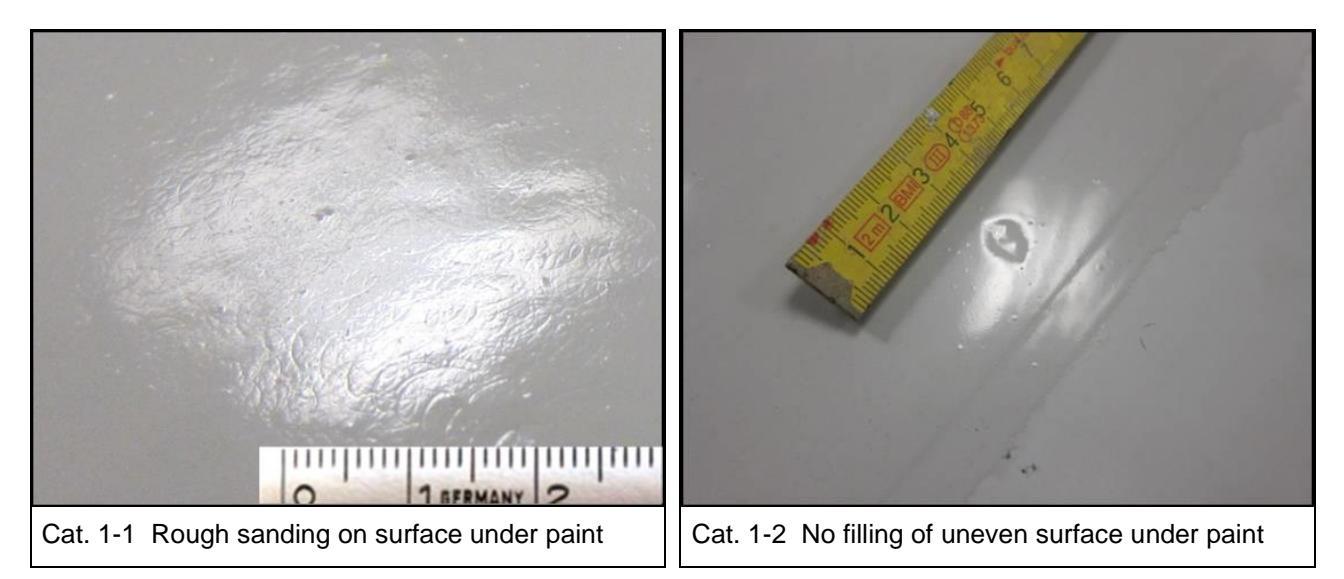
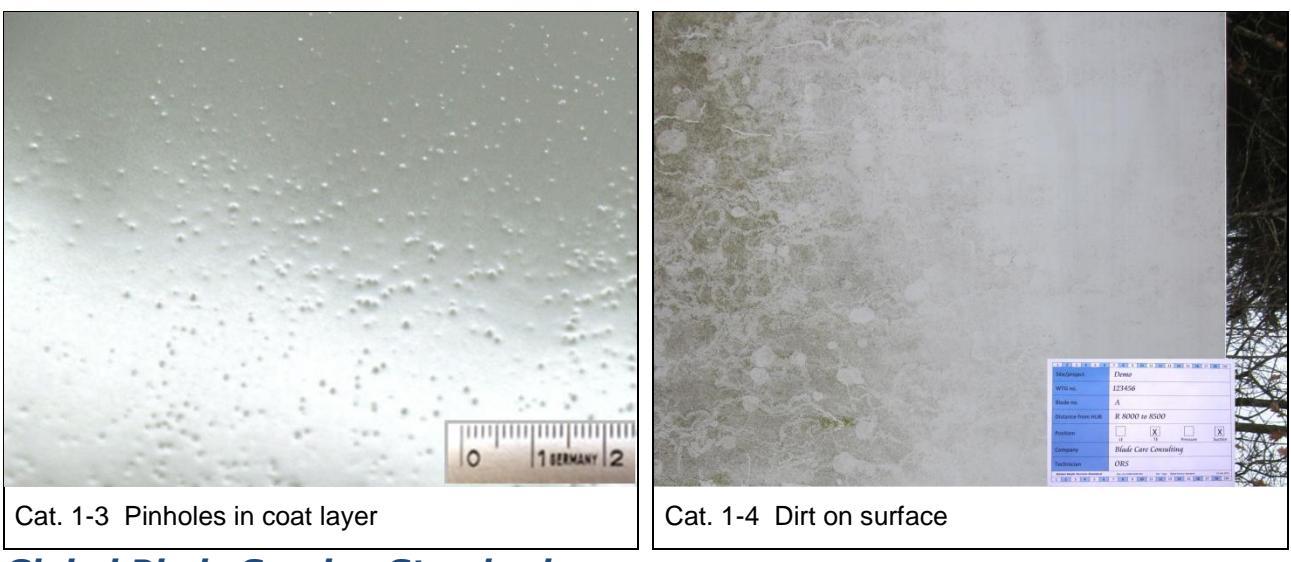
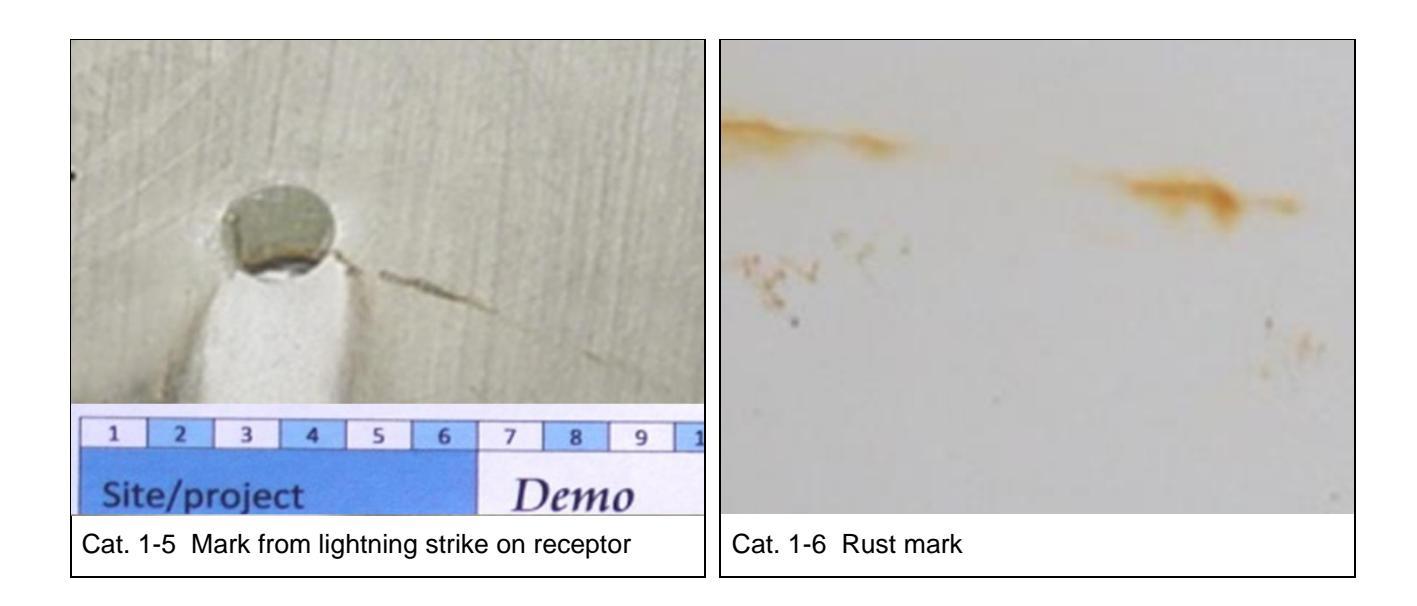
## 11.1 Category 1

Cosmetic defects on blade surface.

Blade surface does not meet the standard of a new blade.

Criteria for placement in category 1:

- No access to laminate below surface coating
- No risk for the defect to expand
- No or minor effect on blade performance

No immediate action to be taken. PMR 24 monthly

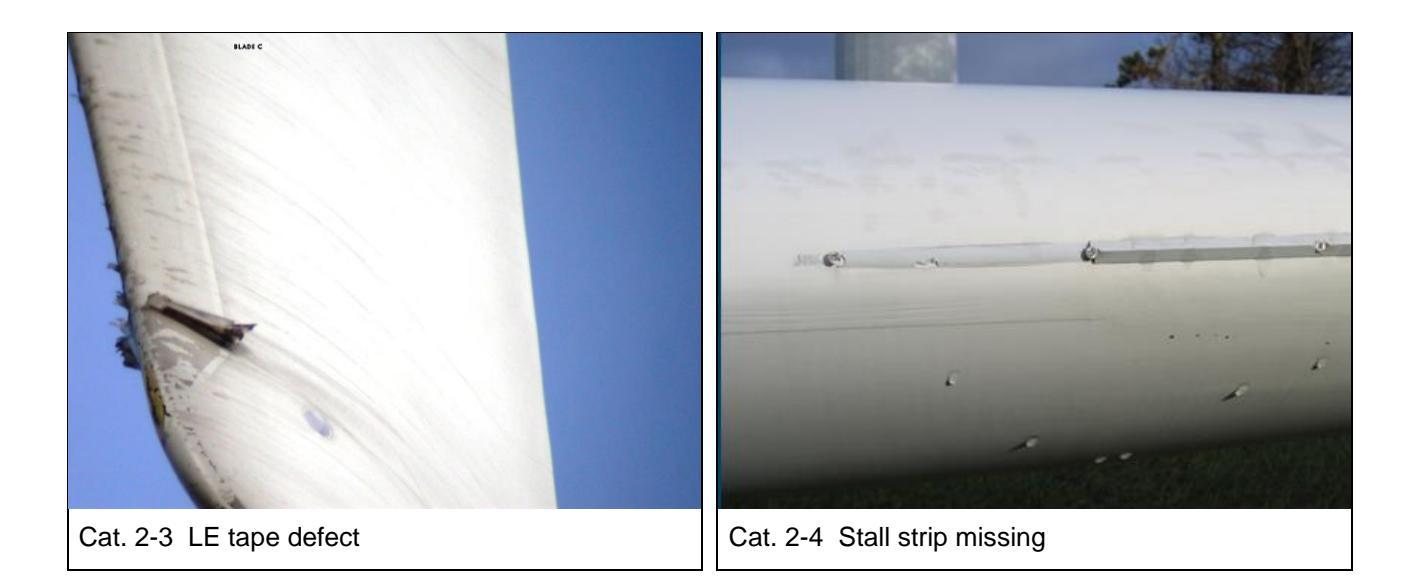
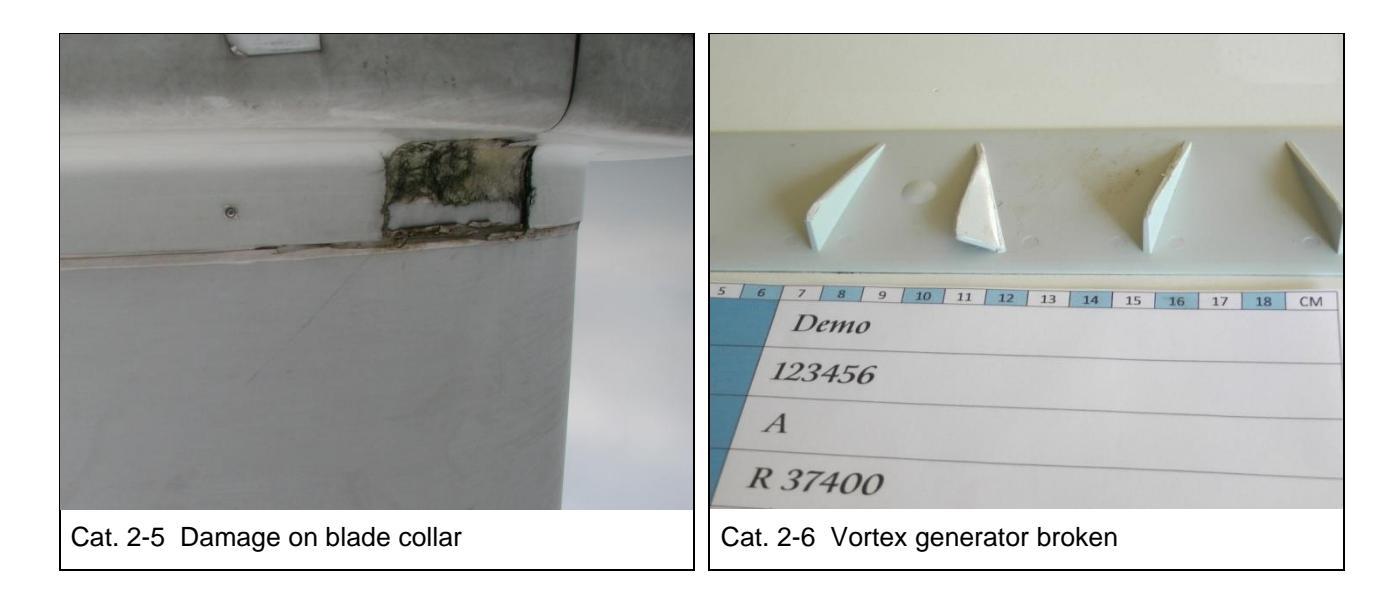
## 11.2 Category 2

Defects in blade surface layer

Gel coat, filler or paint layer is broken/missing and allows access to the laminate.

Defects on Vortex generators, stall strips, Dino tails and LE tape.

Criteria for placement in category 2:

- No immediate loss of laminate strength
- No or minor risk for water ingress in laminate
- No or minor effect on blade performance

1 2 3 4 5 6 7 8 9 10 11 12 13 14 15 16 17 18 CM Site/project Demo 123456 WTG no. A Blade no. R 8000 to 8500 Distance from HUB X Position TE Pressure Suction Blade Care Consulting Company Cat. 2-1 Coating flaking off, small area Cat. 2-2 Incorrect mix of epoxy gelcoat

No immediate action to be taken. PMO 12 monthly

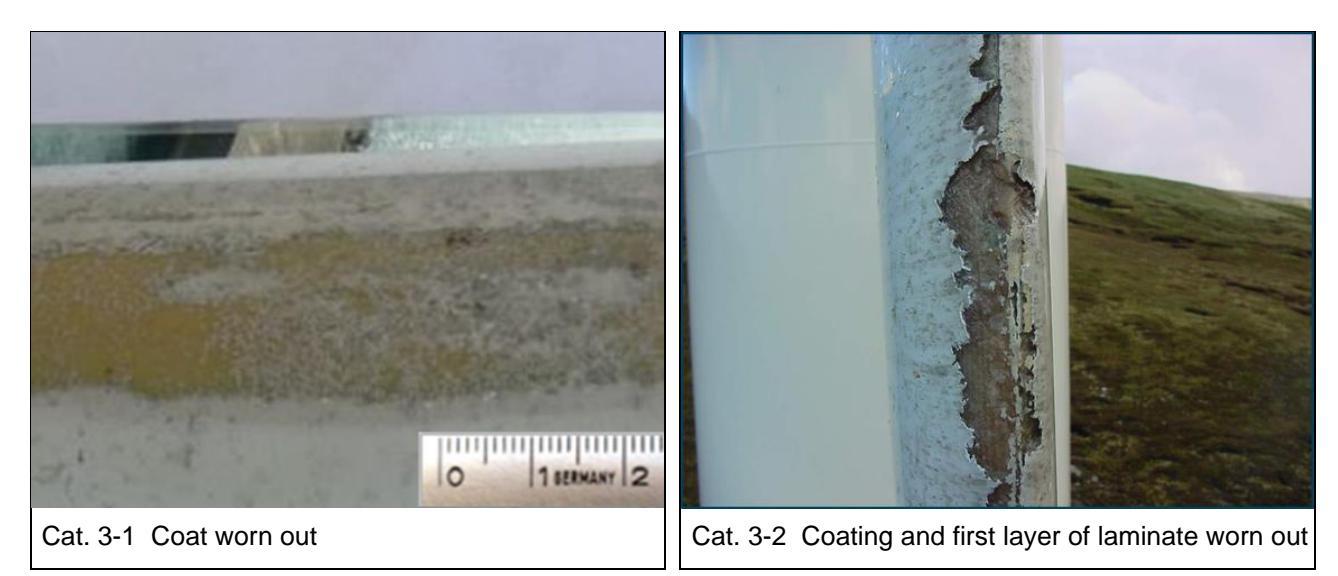
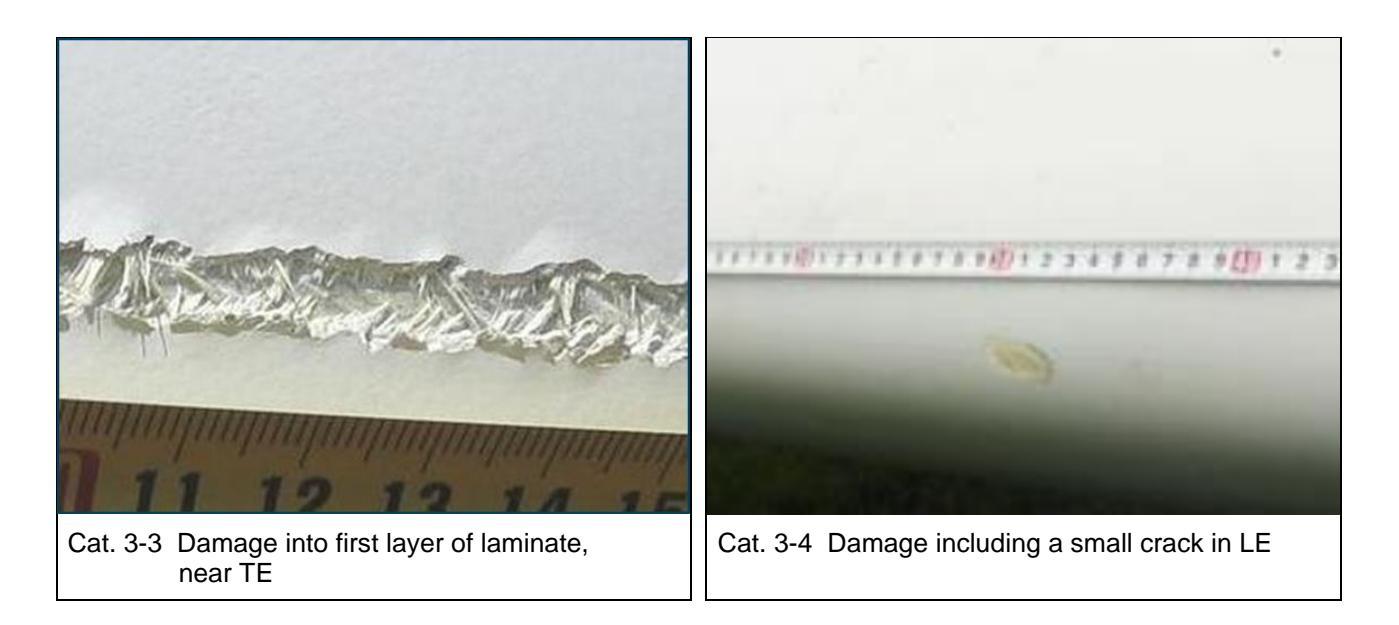
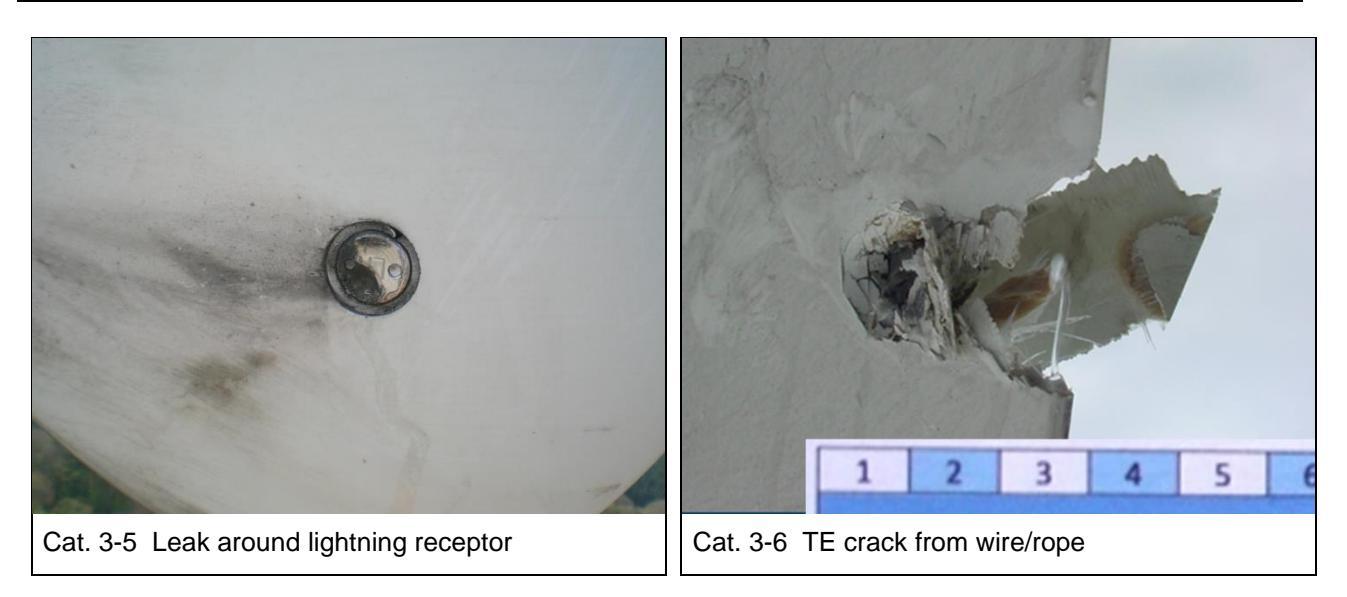
# 11.3 Category 3

Defect and damage in first layer/layers of laminate.

Small bond failure

Small crack in laminate

Criteria for placement in category 3:

- Risk for laminate to loose strength
- Risk for water ingress into laminate
- Only risk for slow development of damage

Action to be taken: ORA to be conducted and PMO raised

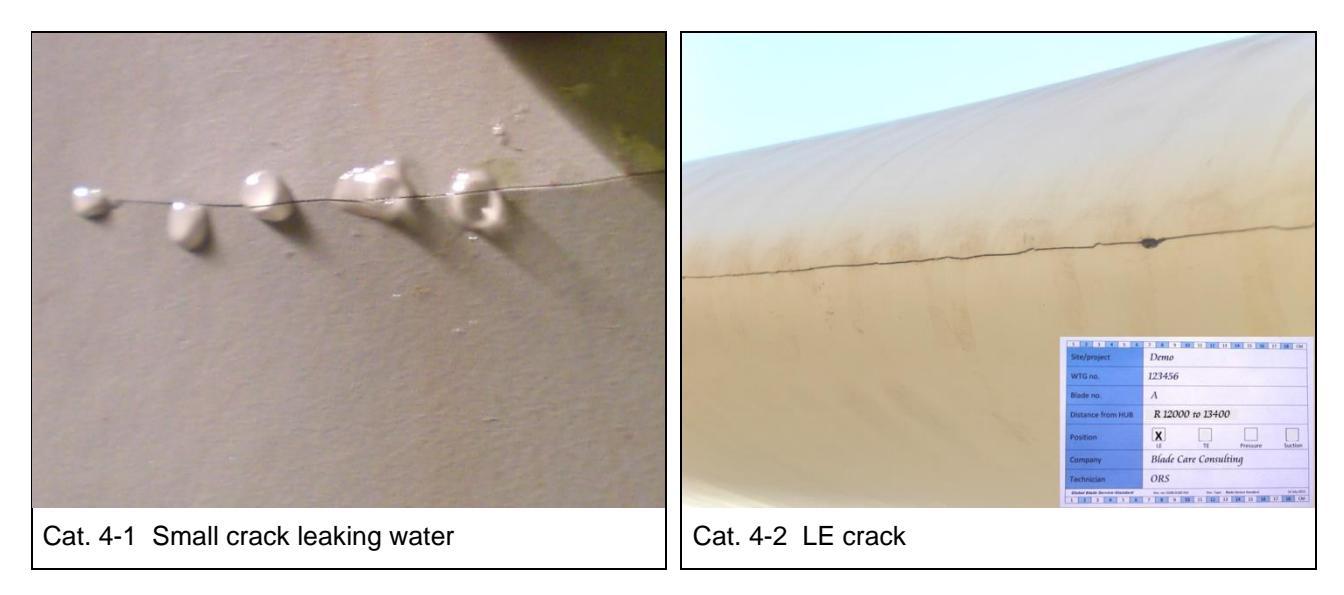
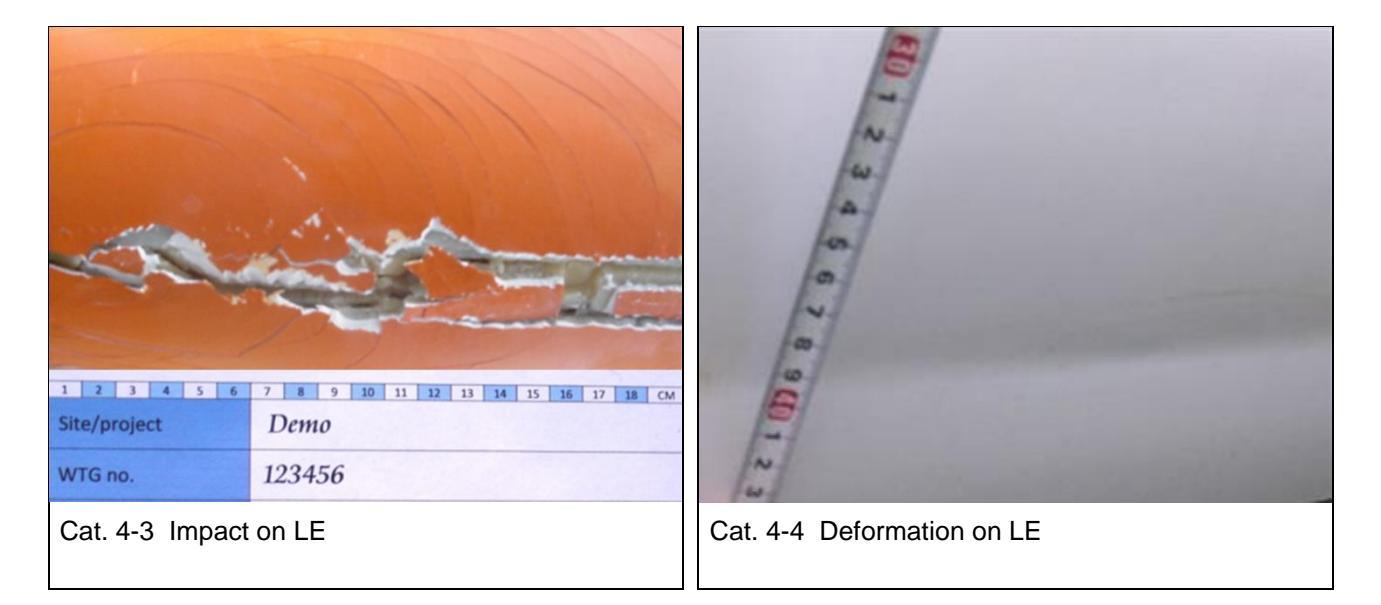
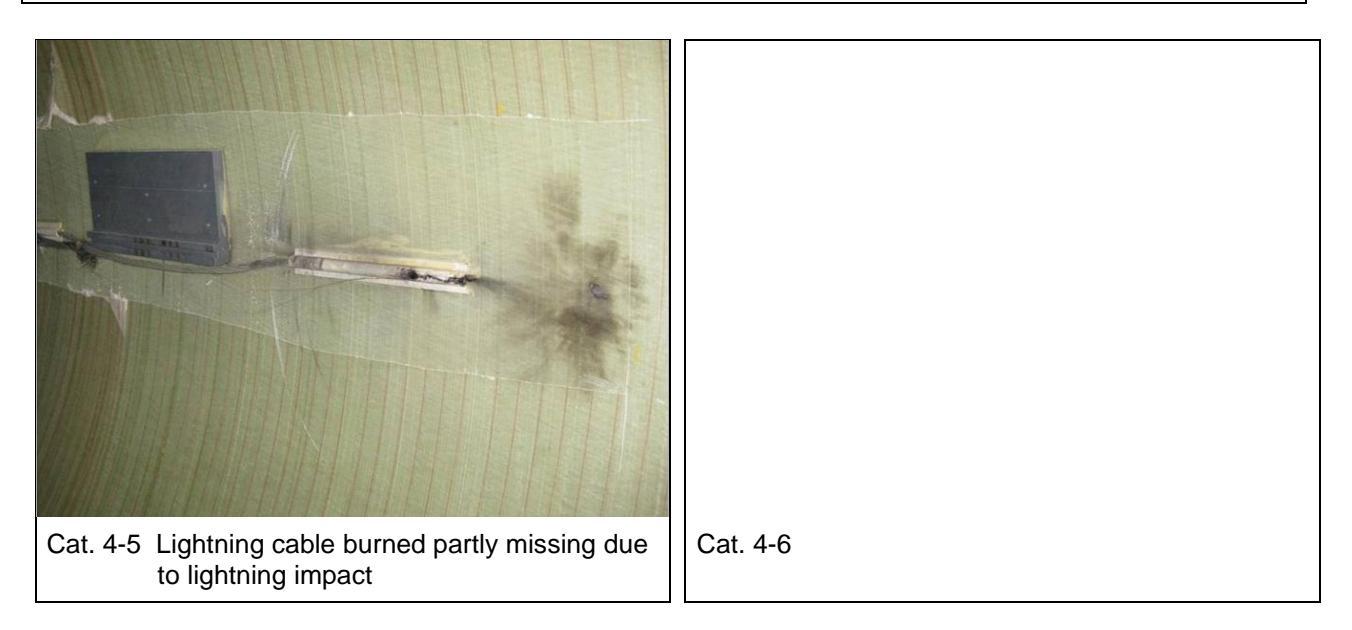
## 11.4 Category 4

Serious damage, on structural parts of blade.

Criteria for placement in category 4:

- no immediate risk of the blade structure collapsing.
- no risk of loose blade parts.
- blade not out of balance.

#### Action to be taken: ORA to be conducted and CMO raised

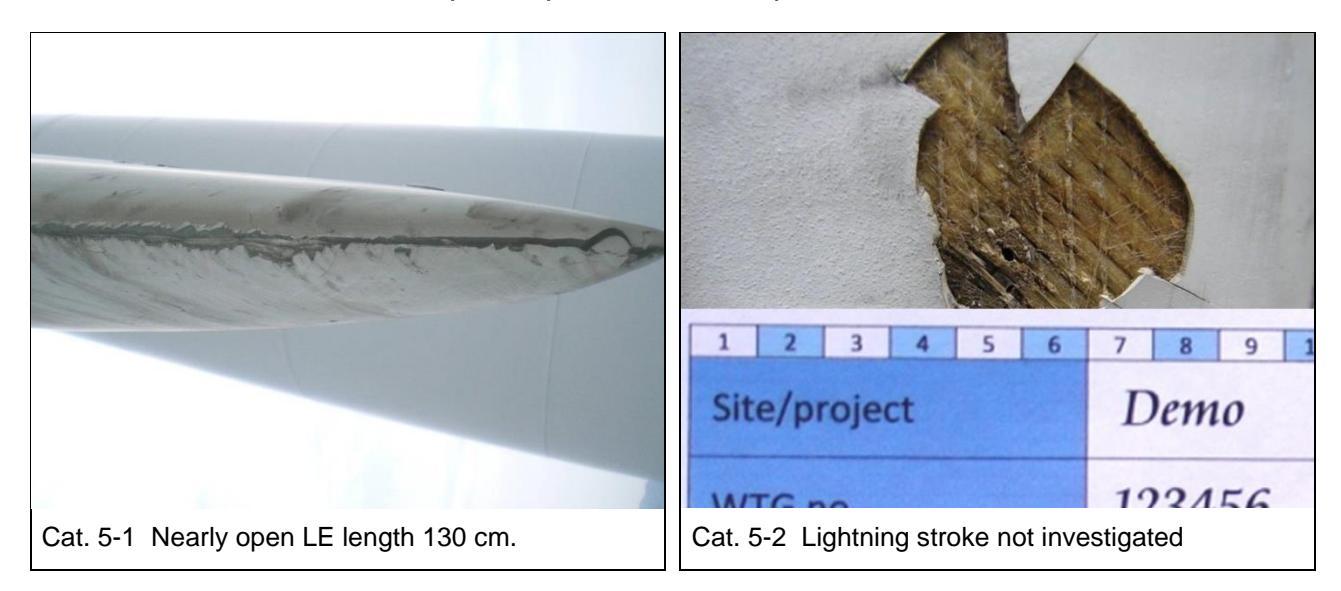
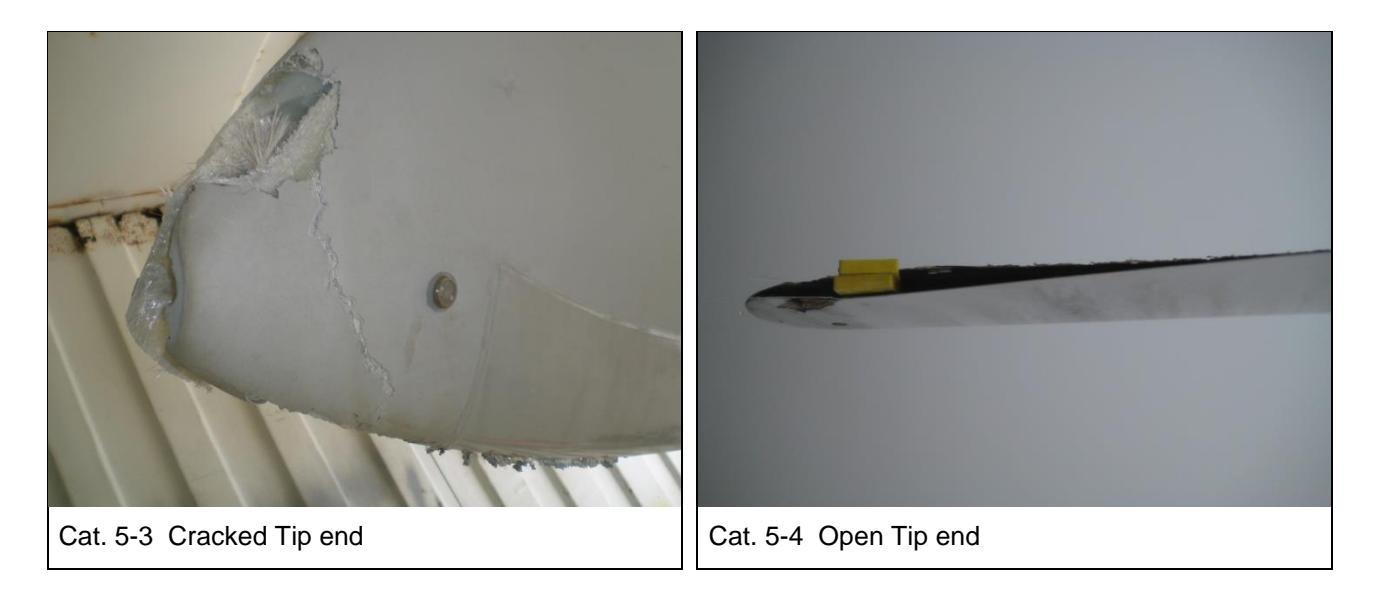
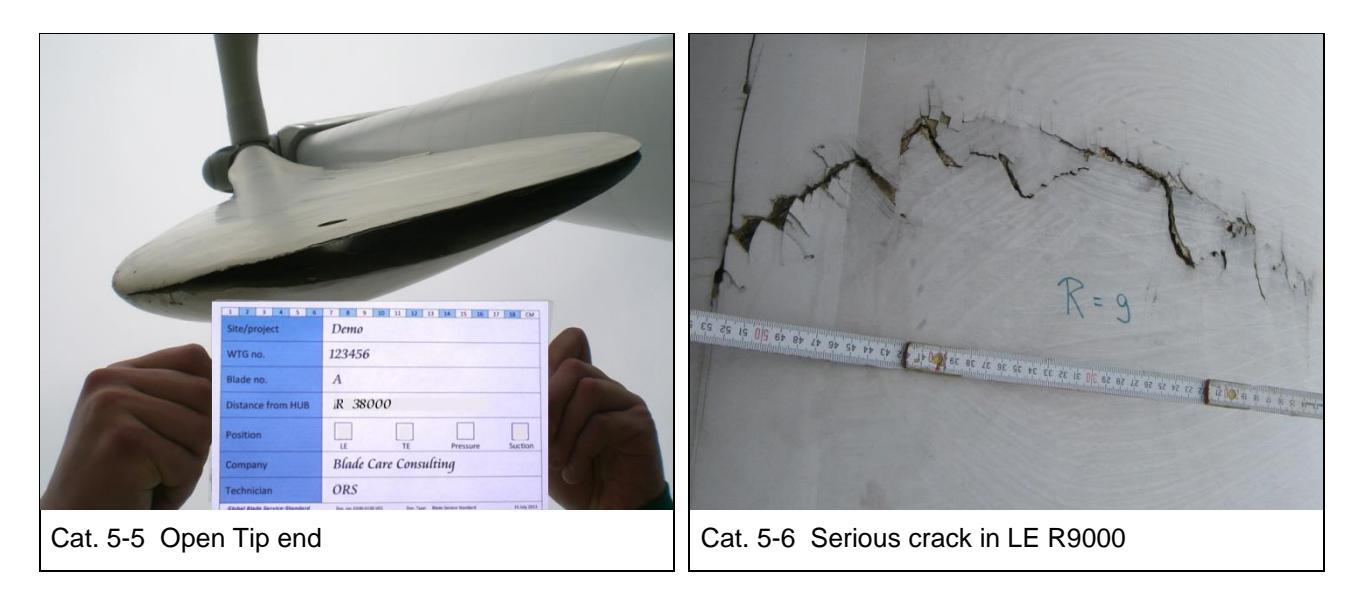
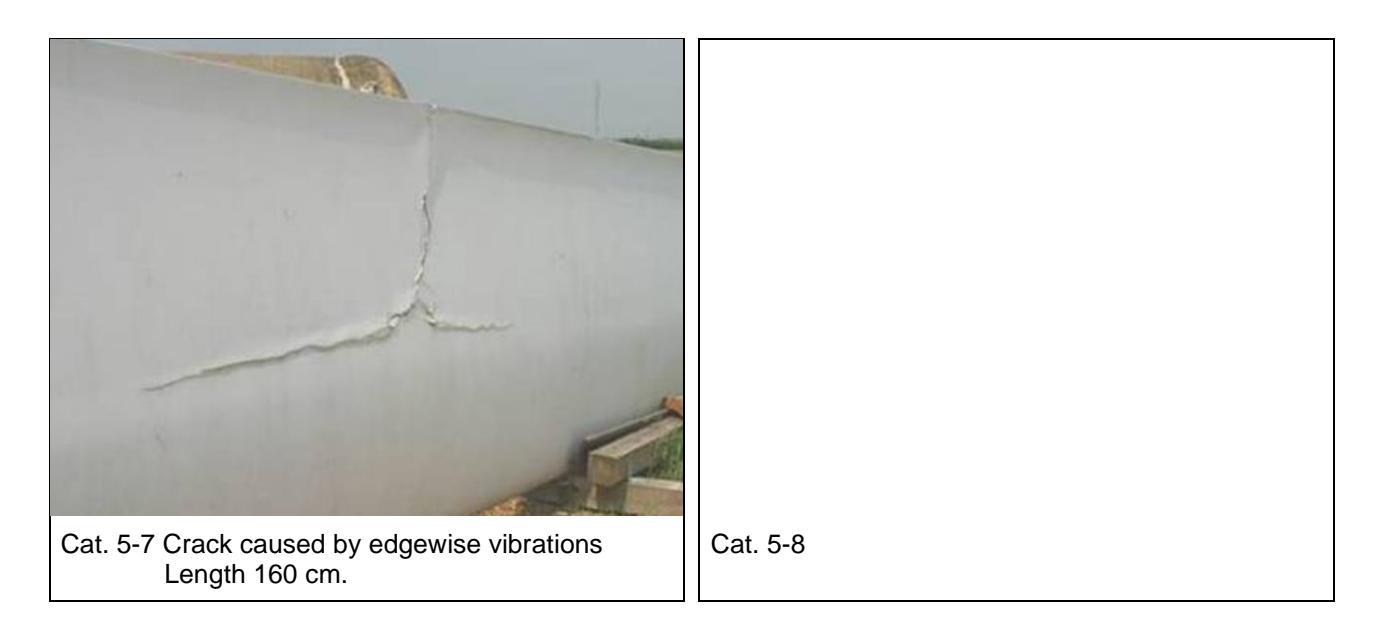
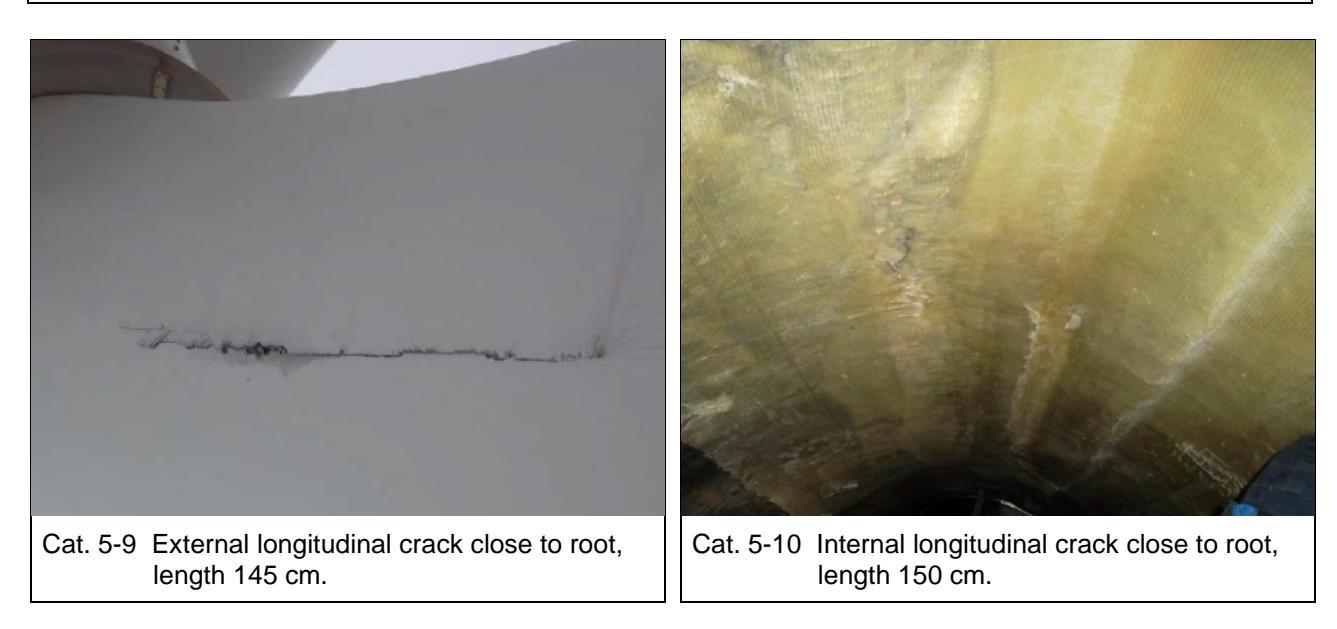
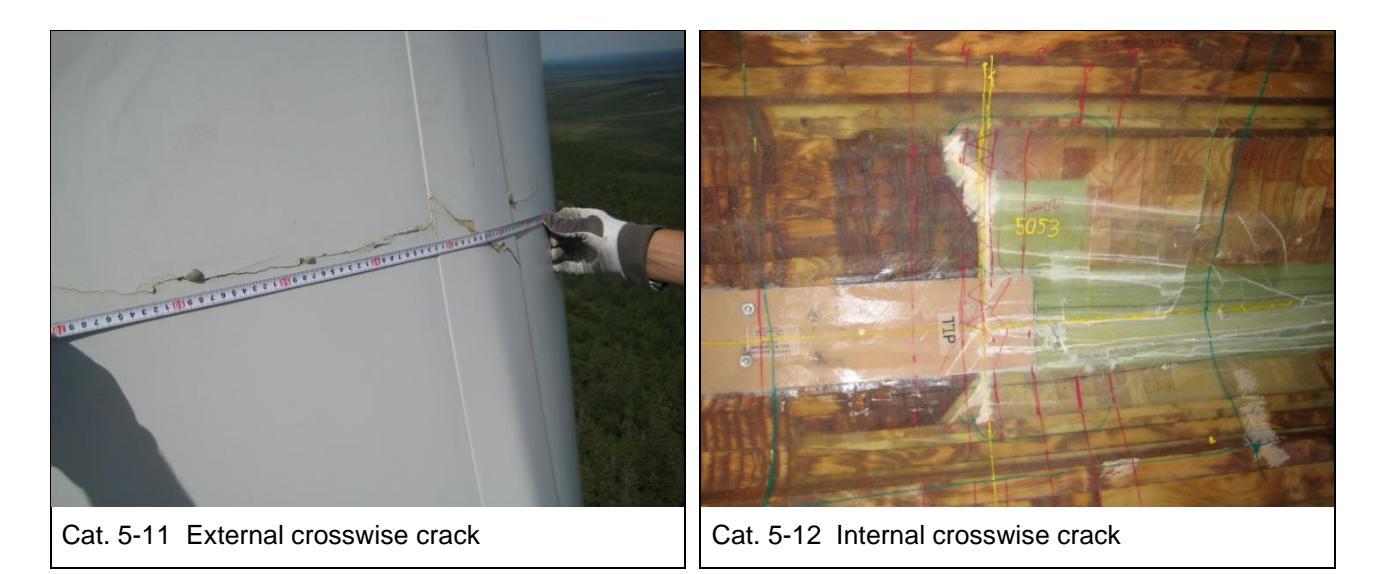
# 11.5 Category 5

Very serious damage on blade structure.

Criteria for placement in category 5:

- Risk of losing parts of the blade
- Risk of the entire blade breaking down.
- Seriously out of balance

Turbine must remain stopped.

Action to be taken: CMO completed prior to further operation
